Report on Accident at Production Facilities at Shimonoseki Mitsui Chemicals, Inc.

Mitsui Chemicals, Inc. ("MCI") and Shimonoseki Mitsui Chemicals, Inc. ("SMCI") once again extends sincerest apologies to all those who suffered injuries, the residents of the local community and all other parties concerned and affected by the November 4, 2009 accident at the filling area of the nitrogen trifluoride (NF<sub>3</sub>) production facility (Line F3/F4) at Shimonoseki Mitsui Chemicals, Inc.

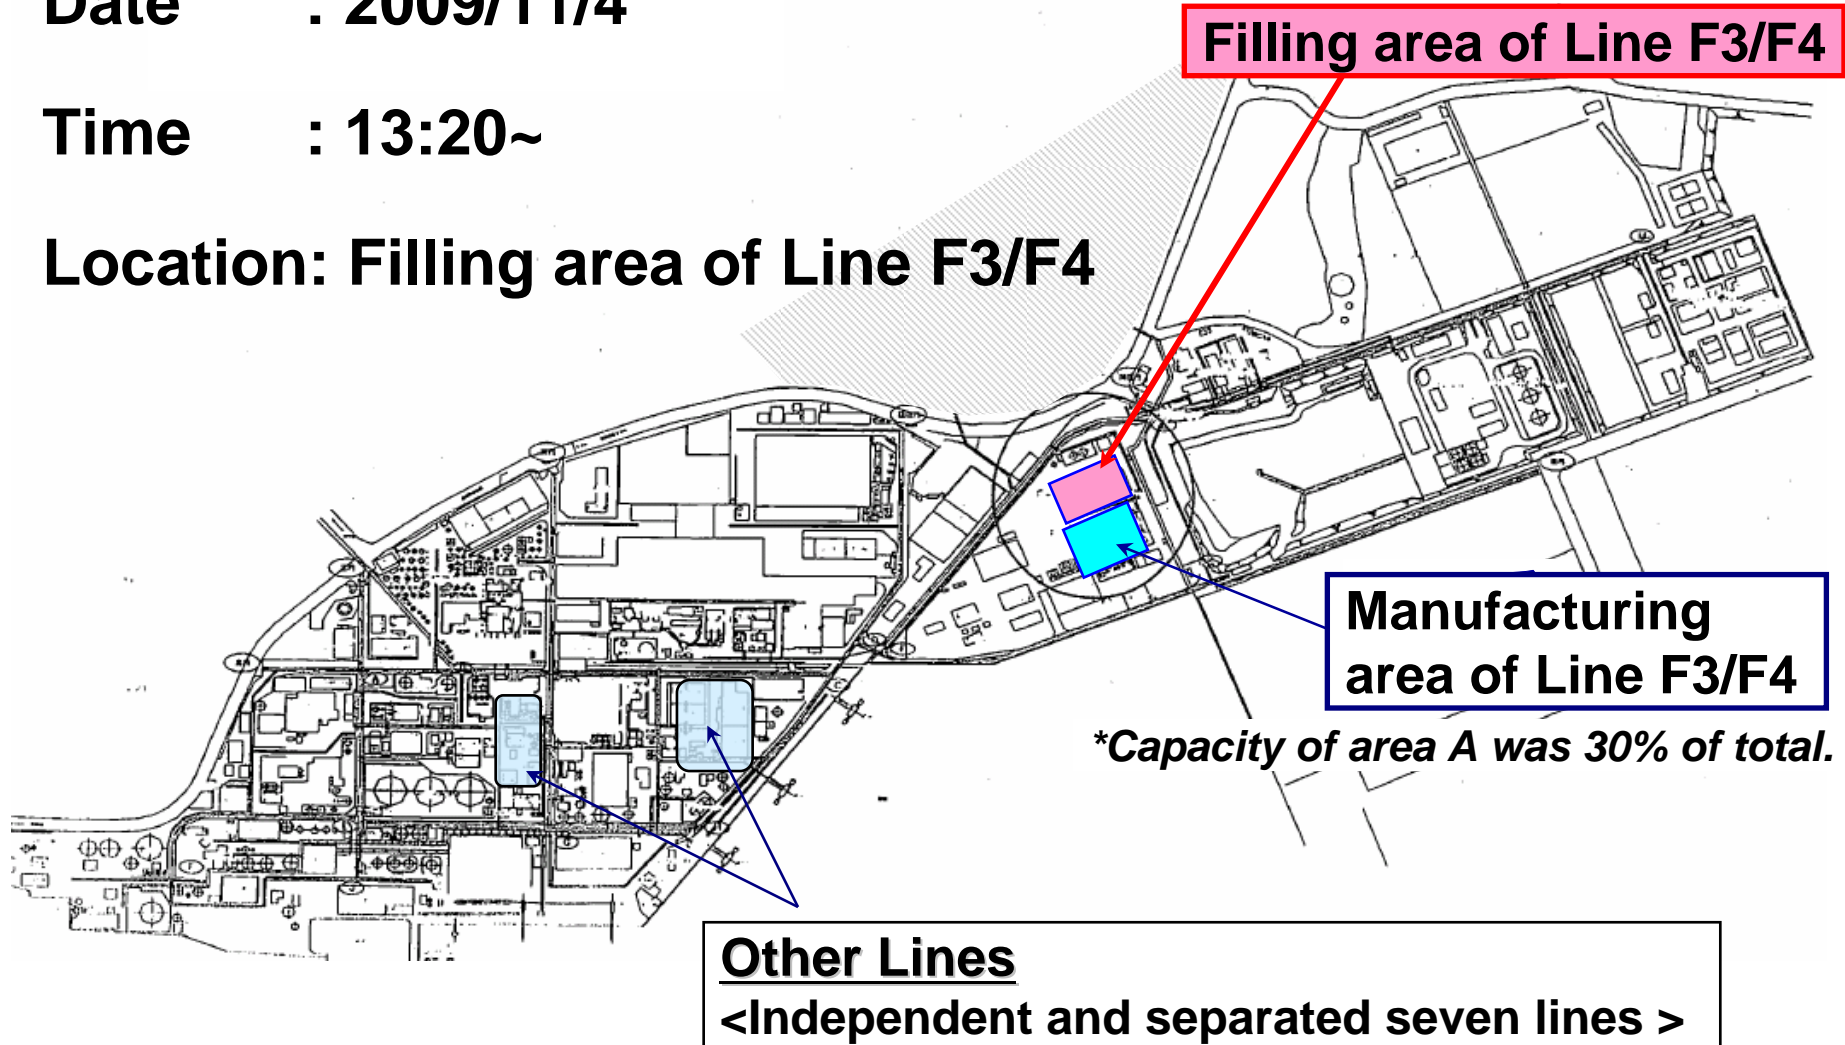
# Incident Overview

Date : 2009/11/4

Time : 13:20~

Location: Filling area of Line F3/F4

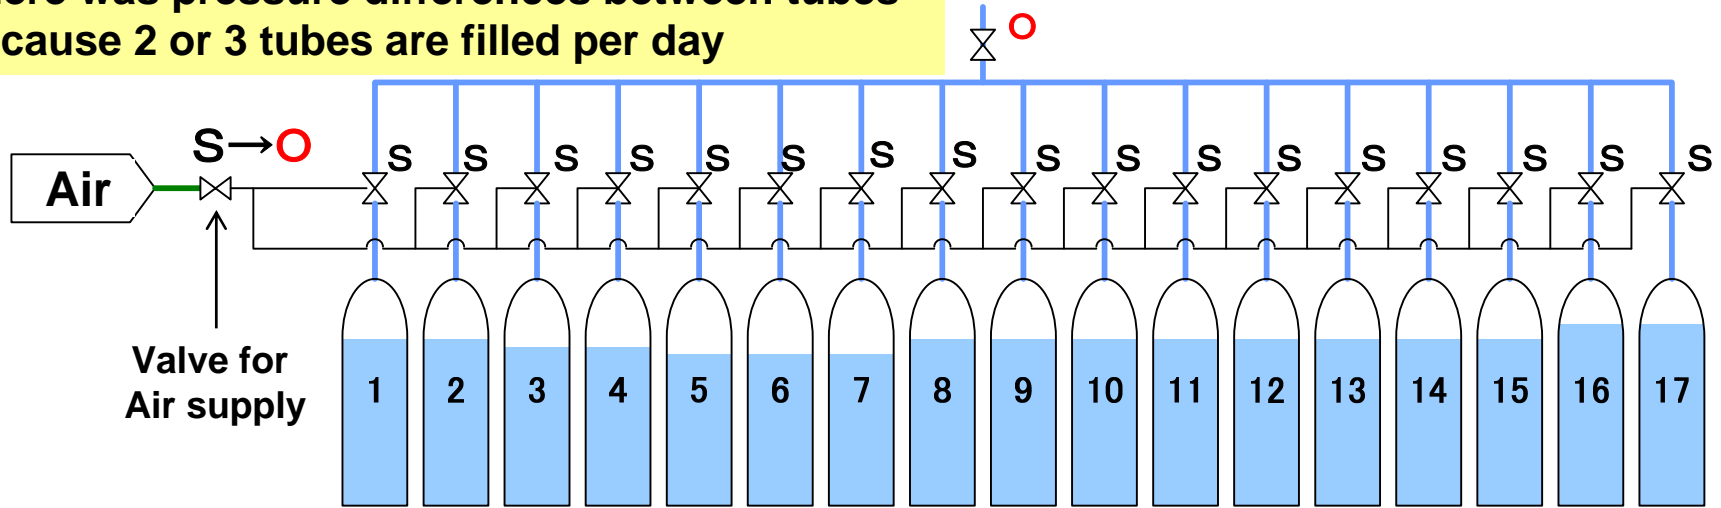
# Root cause : 'Open all valves at once'

There was pressure differences between tubes because 2 or 3 tubes are filled per day

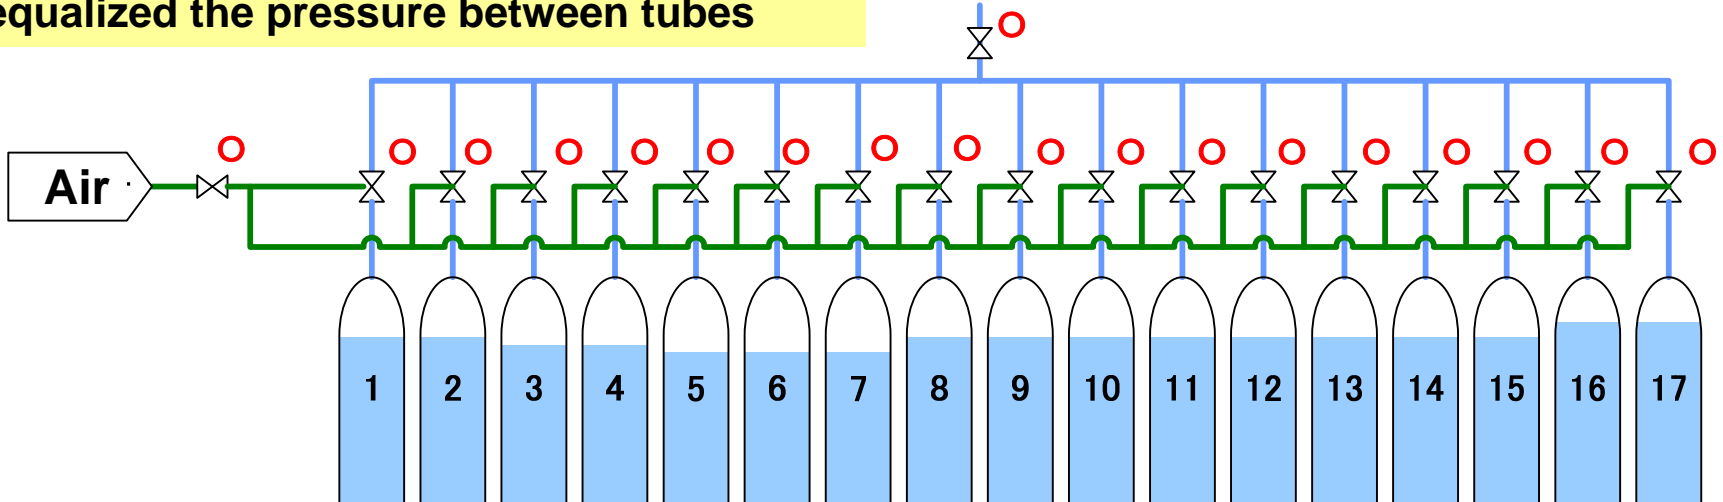
Opened air valve to the tube valves  
→ All tube valves were opened at once and equalized the pressure between tubes

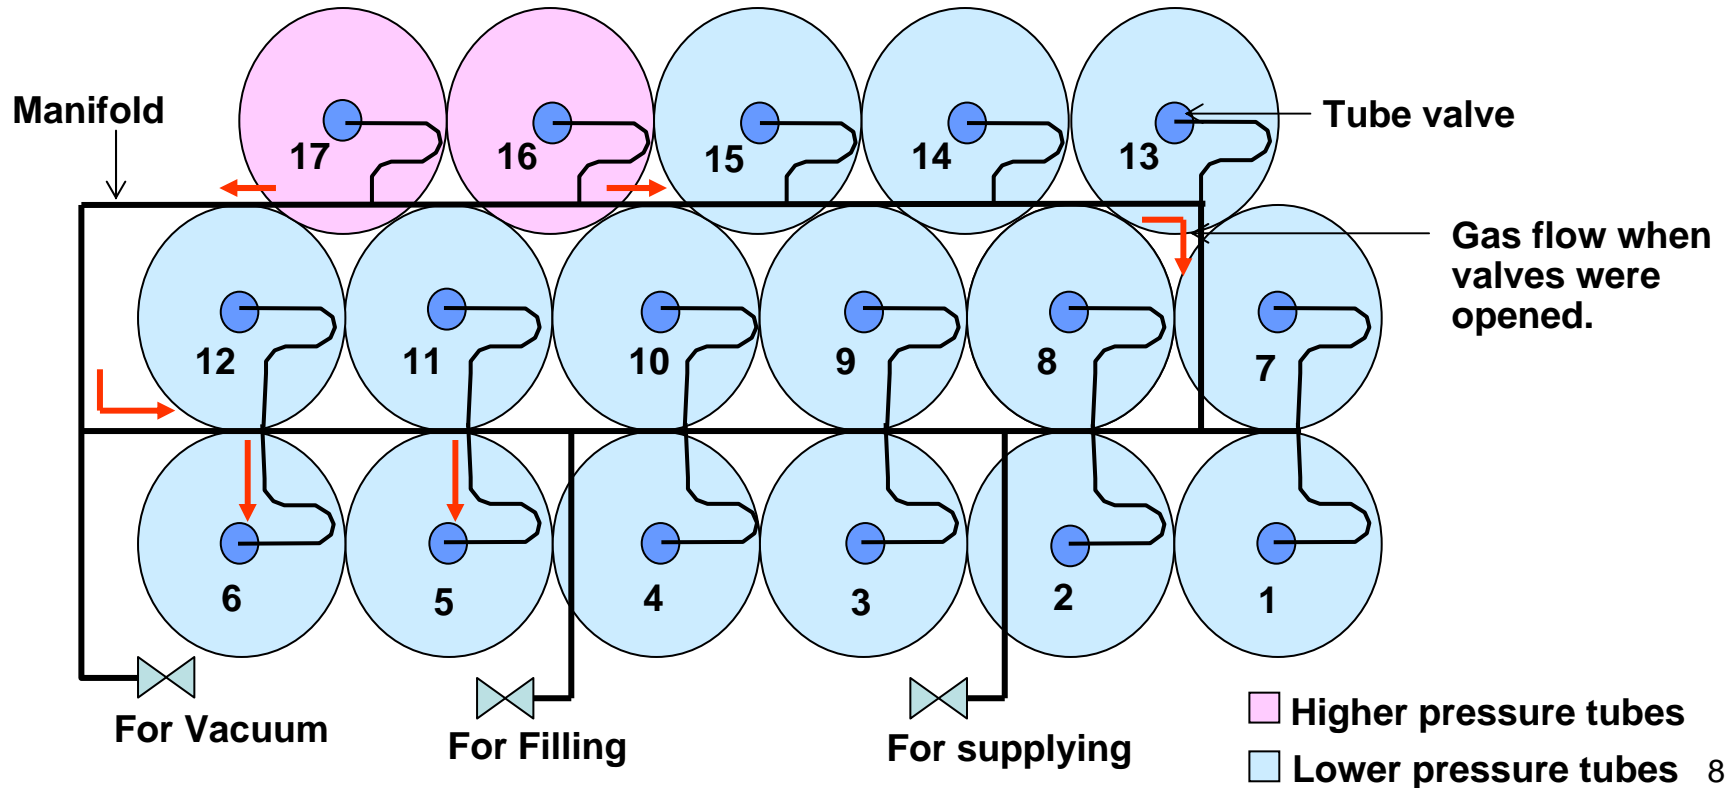
# Image for 'the gas flow when all valves were opened at once'

We had pressure difference between tubes because we filled 2 or 3 tubes each.

All tube valves were opened at once by supplying air

NF3 in the high pressure tube moved quickly in the manifold into the low pressure tube to equalize the pressure.

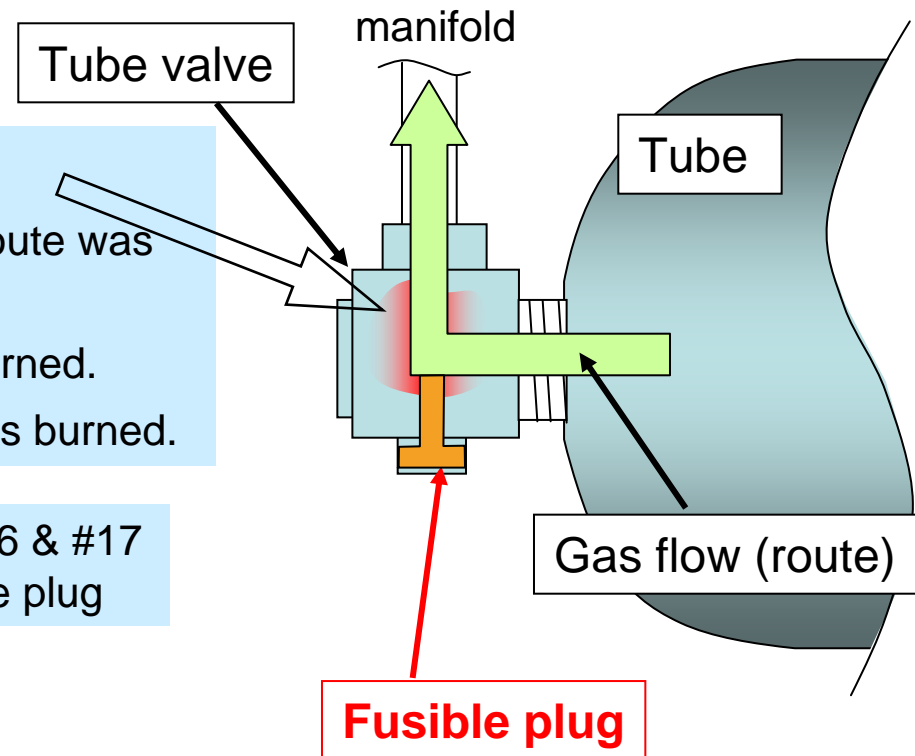
# Mechanism of the fusible plug failure

After filling the 17 cluster tube trailer, the worker simultaneously released the main valves of all tubes to conduct NF<sub>3</sub> gas analysis. It is probable that the differential pressure between the tubes caused high density, high volume NF<sub>3</sub> to flow through the tube valve. The flow friction caused the temperature of the tube valve to rise. The rise in the tube valve temperature caused hot molten metal from the fusible plug to burst out with NF<sub>3</sub> gas which was heated in the tube valve. It is assumed that the molten metal became a combustive source igniting the surrounding vinyl chloride curtains (flame retardant) to start the fire.

All tube valves were opened when there is pressure difference between tubes

High density NF3 flew through #16 and #17 valves with high flow

**Flow friction caused higher temp.**

- Stainless steel on the surface of flow route was reacted with NF3
- PCTFE around diaphragm seat was burned.
- PCTFE packing around fusible plug was burned.

Burst #16 & #17 fusible plug

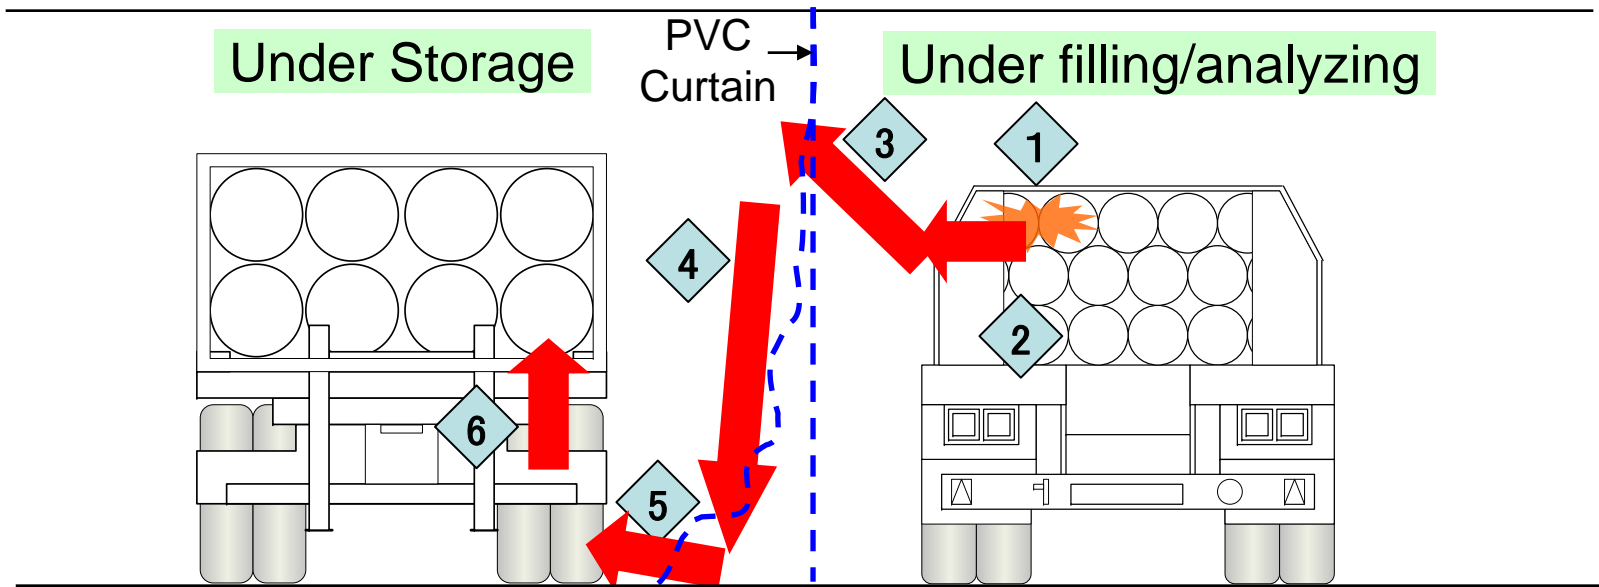
# Mechanism of the tube burst

It is probable that fire occurring in the 17 cluster tube trailer spread to the tire of the 8 cluster tube trainer that was stored in the same filling area, heating the tube directly above the tire. This raised temperature inside the tube causing a reaction between NF<sub>3</sub> and material of the tube. The pressure inside the tube increased rapidly and mechanical strength of the tube decreased causing the tube to explode.

1. Melted metal of the fusible plug on the valve became the source of the fire.
2. NF3 was supplied through burst plug to cause fire.
3. Flame was ignited to the curtain which was made of PVC.
4. Curtain was burned and fallen down.
5. And it was ignited to the tire.
6. Tire was burned, heated the tube and burst.

***\*NF3 assists to make flammable material fire as same as O2.***

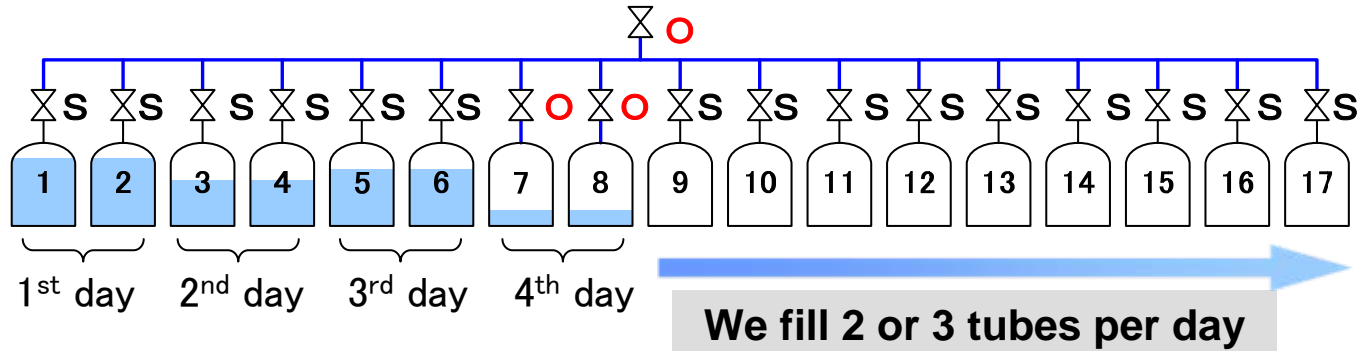
# Safety measures : How to fill tube trailer w/o pressure difference

Before incident ; Fill separately

\*It is difficult to make all tubes same pressure
