Accident Investigation Committee Report on
the Iwakuni-Ohtake Works Explosion and Fire

Mitsui Chemicals Iwakuni-Ohtake Works
Resorcinol Plant
Accident Investigation Committee Report

Resorcinol Plant Accident Investigation Committee
Mitsui Chemicals Iwakuni-Ohtake Works

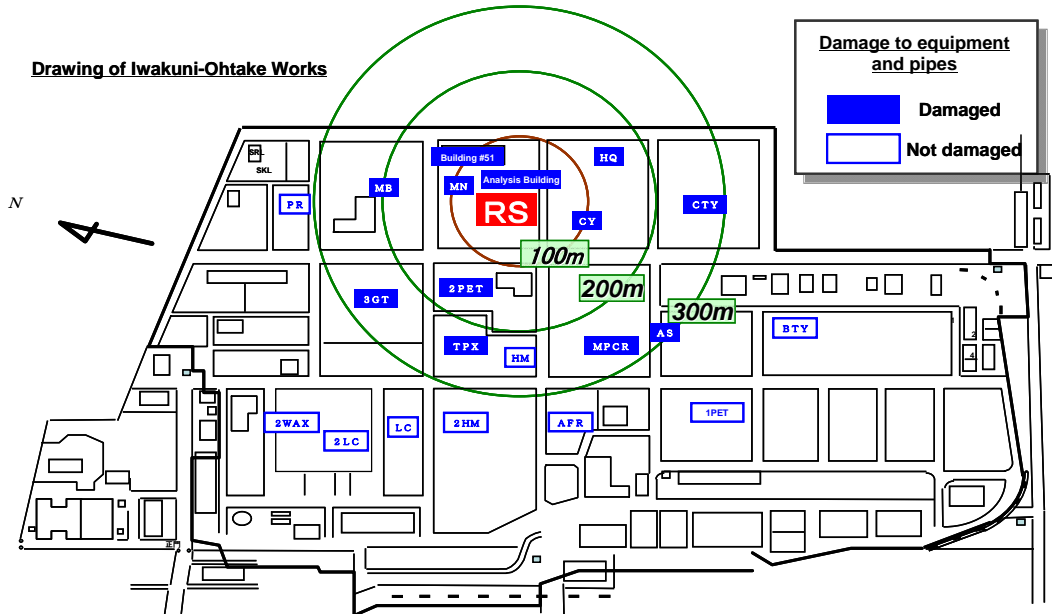
Figure 2-2 Damage within plant premises

Damage to equipment and pipes were found in a 300m radius around the resorcinol plant. (Refer to Fig. 2-2)

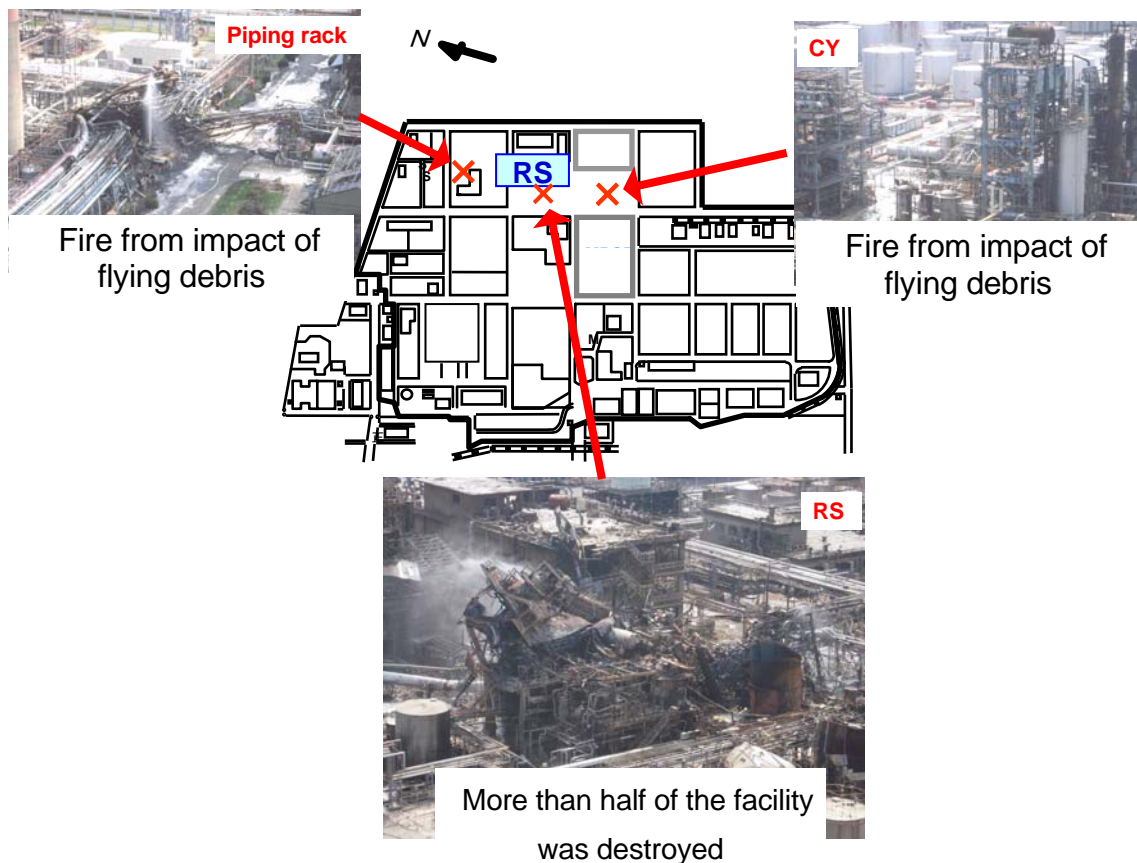
Figure 2-3 Damage to area surrounding the resorcinol plant

Fig. 2-3 shows an enlargement of the location where the fire occurred. More than half of the resorcinol plant was destroyed. At the cymene plant and the utilities piping rack, large broken pieces of the resorcinol oxidation reactor were discovered where the fire started, and there was damage from the impact of the flying debris.

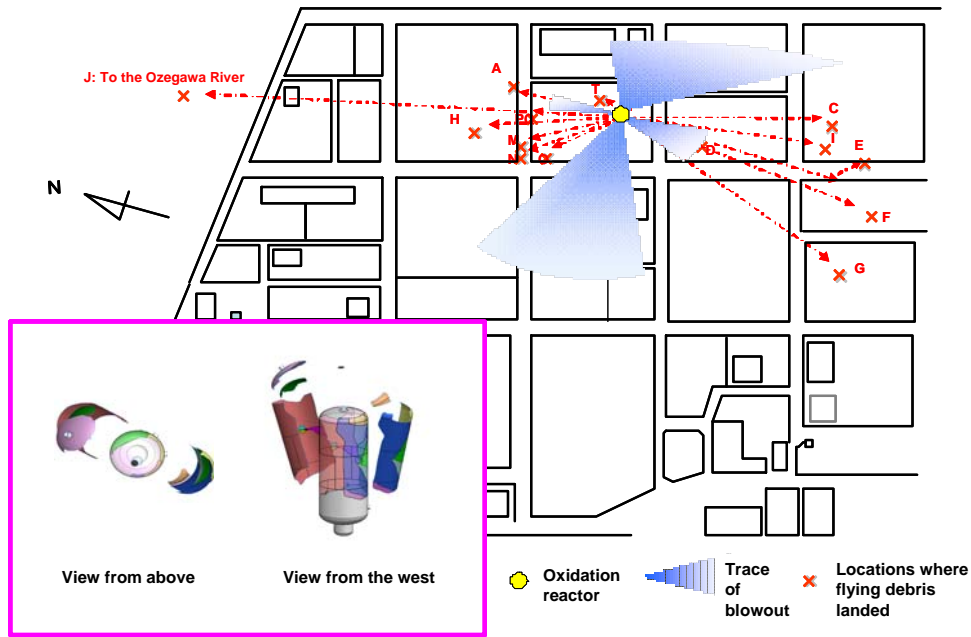
Figure 2-4 Scattering of the Oxidation Reactor

The upper part of the oxidation reactor had broken into pieces and was scattered in the explosion, leaving only the skirt and the lower part of the main body (Fig. 2-4). The scattered pieces were distributed to the north (Hiroshima side) and south (Iwakuni side) of the location where the oxidation reactor was installed. The contents of the reactor were scattered to the east and west.

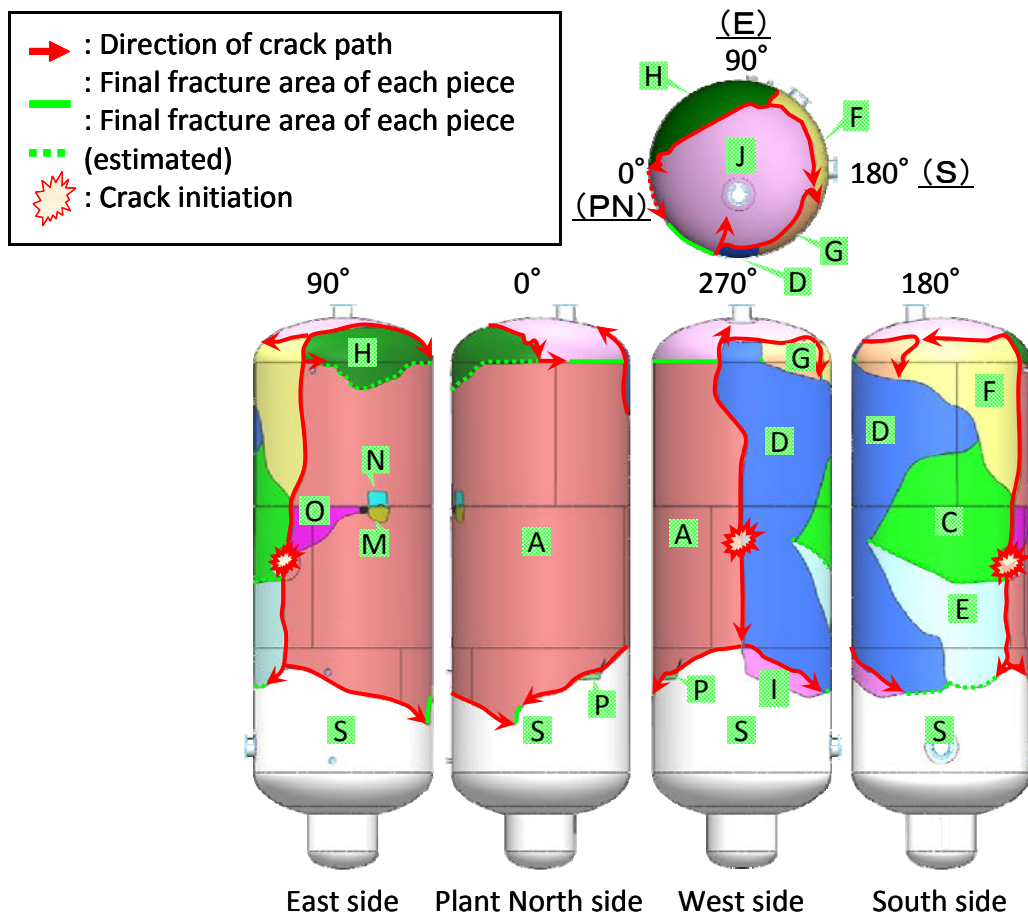
Figure 2-5 Crack initiation and crack paths

Figure 2-5 shows the estimated crack initiation and crack paths based on a visual observation of the fracture surface. It was estimated that the initiation was at the manhole which was a discontinuous part of the structure located near the 120° radius direction and at the insulation rib located near the 270° radius direction.

The size measurements showed that the circumference and longitudinal length of the reactor had grown and the thickness was reduced on all of the fracture surfaces.

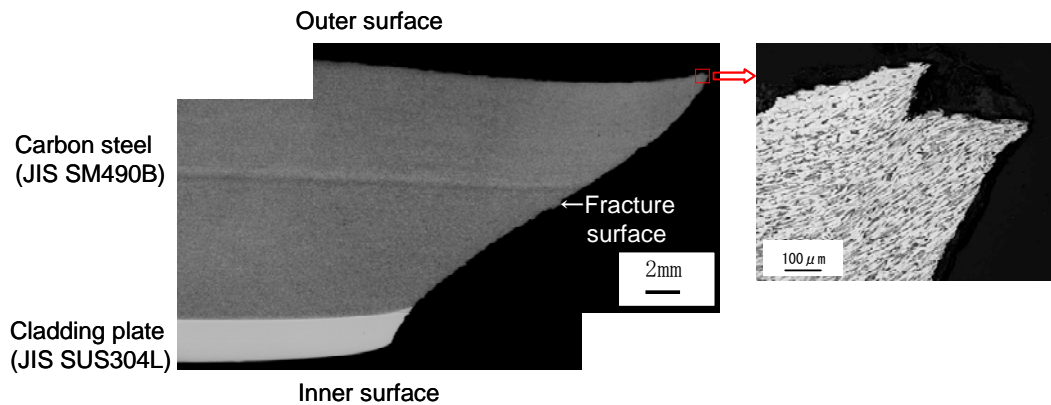
Figure 2-6 Observation of texture of fracture surface

Reduction in thickness and elongation of the microstructure from plastic deformation due to the rise in internal pressure were observed and dimples, a characteristic feature of ductile ruptures, were confirmed on all of the fracture surfaces of the initiation, crack paths and final fractured parts.

Figure 2-6 shows the cross section of the fracture surface of the reactor near the manhole that is thought to be the initiation point on the 120° radius direction (Piece C) and Figure 2-7 shows the dimple fracture surface observed on the same piece in Figure 2-6.

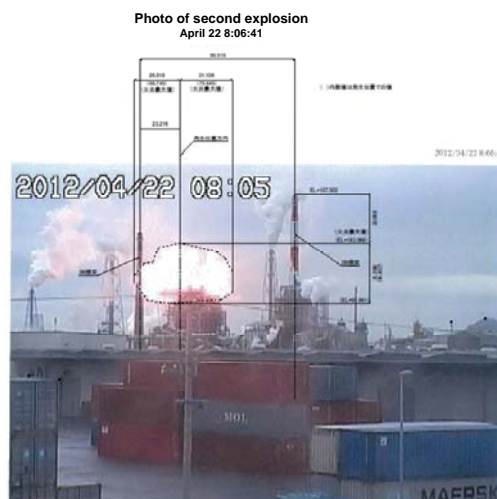
Figure 2-8 Image of the second explosion

Based on these observations, it is thought that after the first explosion, the oxidation reactor was not cooled sufficiently and since there continued to be small fires in the surrounding area, the reactor was heated. The heating caused the temperature of the hydroperoxide (HPO) remaining at the bottom of the reactor to rise and accelerated self-decomposition causing large quantities of flammable gas to burst out. The flammable gas and the residual liquid (mist) in the reactor were scattered and ignited to create a fire ball as shown in Figure 2-8.

After the first explosion, the people onsite responded appropriately to the situation and managed it properly and as a result there were no further casualties from the second explosion and a secondary disaster was prevented.

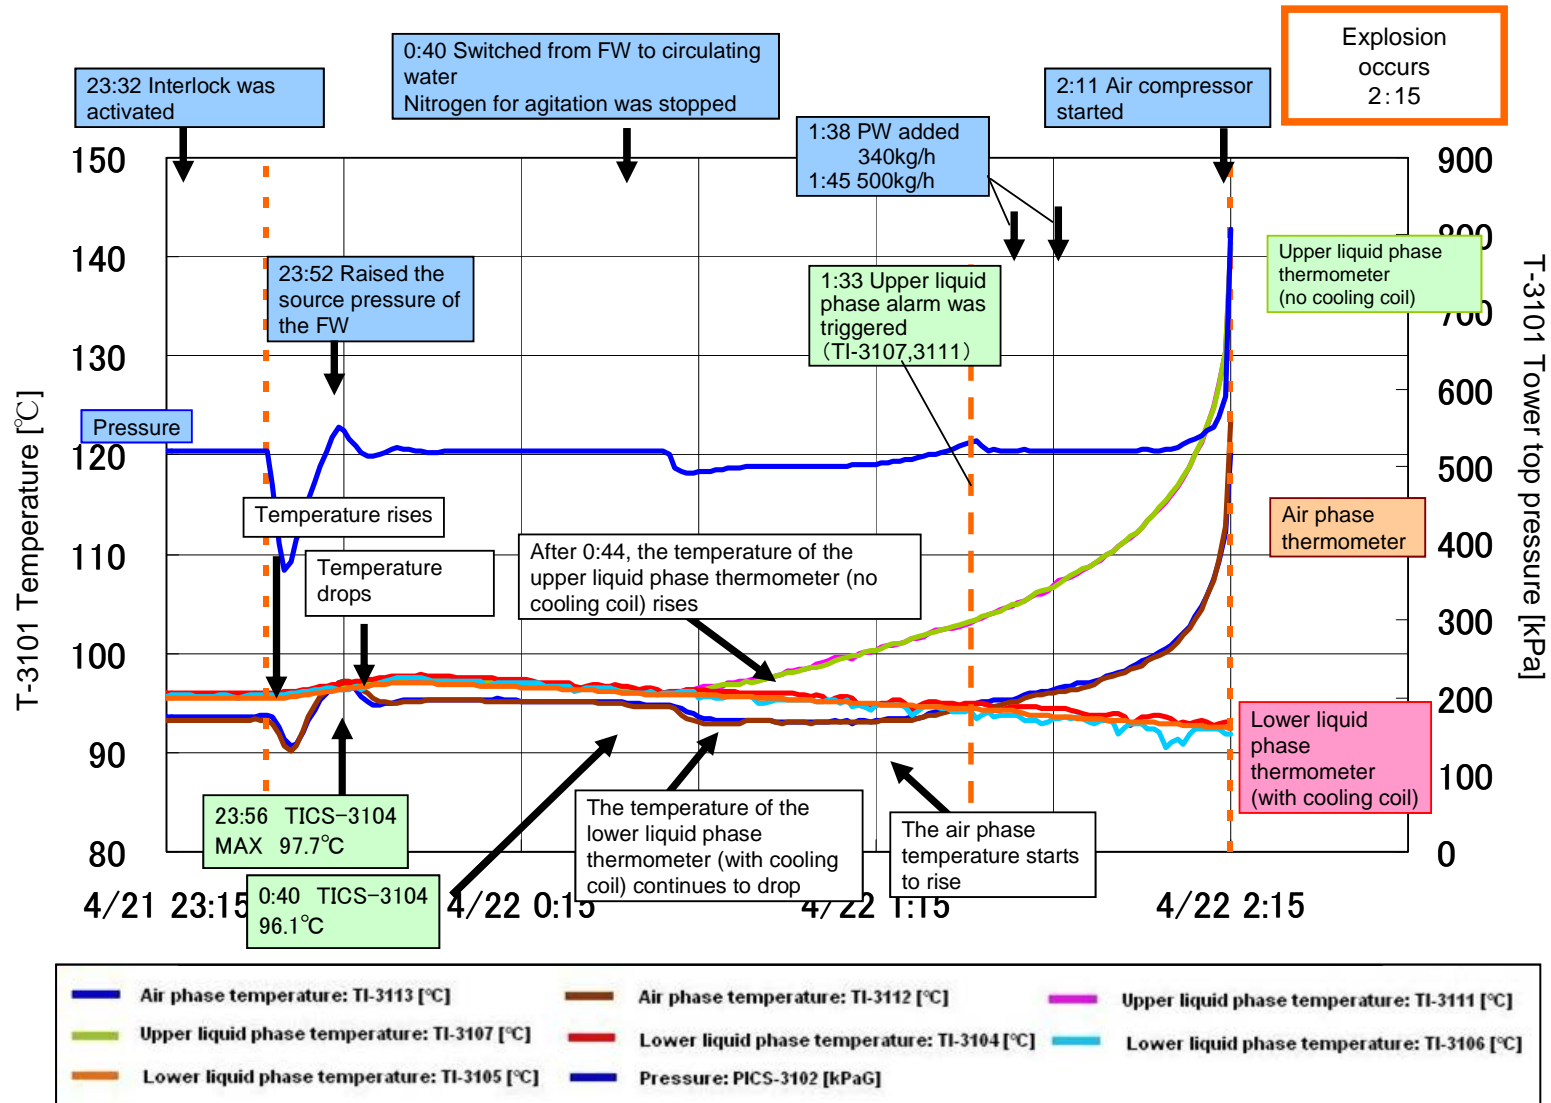
Figure 4-4 Operation condition up to the explosion and fire and temperature and pressure trends

- 2:15
- The pressure exceeded the design pressure of 0.8 MPaG causing the oxidation reactor burst and a fire was started.

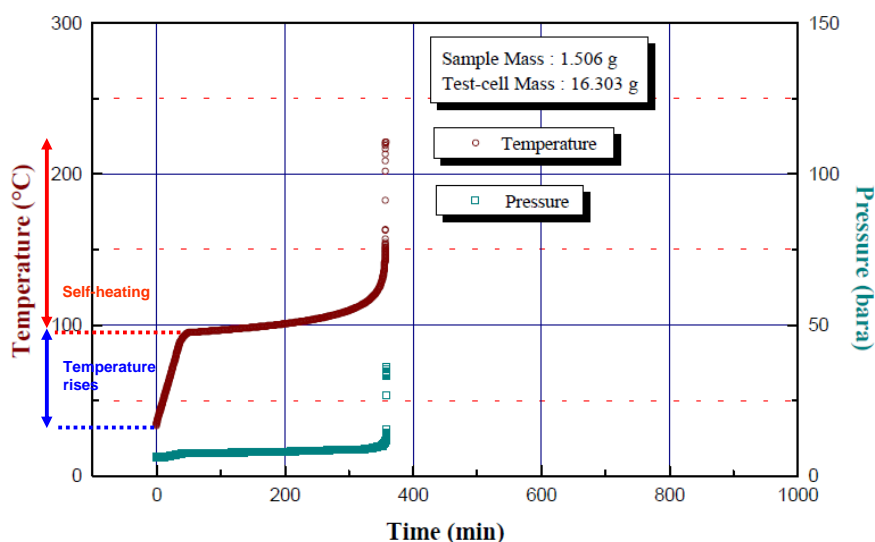
Figure 4-6 Arc measurement results of the oil layer of the small test mixture (after pre-treatment) (Actual measured values)

The results of the ARC measurement are as shown in Figure 4-6 and it was confirmed that in an adiabatic condition, when the temperature rises, self-heating is pronounced and both the temperature and pressure rise suddenly.

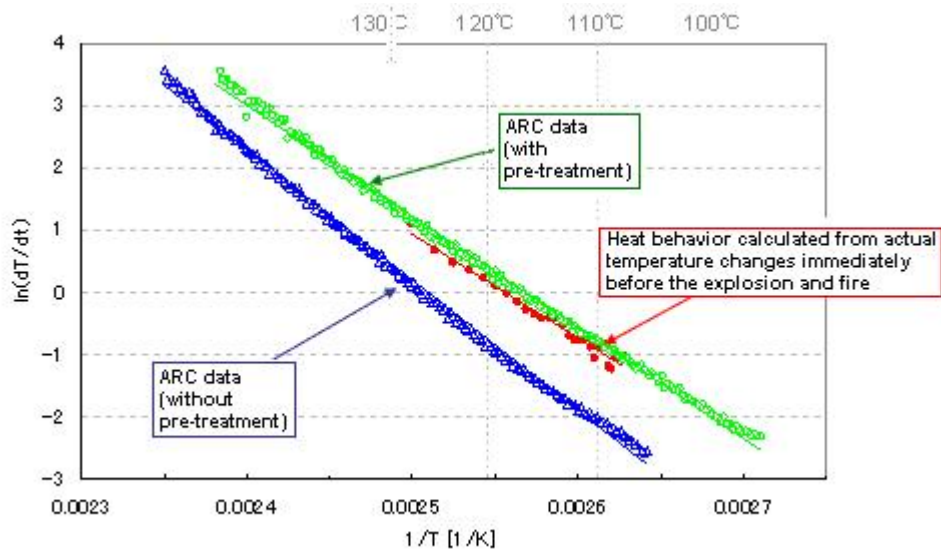
Figure 4-7 Results of ARC analysis of oil layer of the small test solution (with and without pre-treatment) and changes in temperature when the explosion and fire occurred (The unit for dT/dt is [K/min]. Adjusted for specific heat)

Next, an Arrhenius plot was used to organize the ARC measurement data and as you can see in behavior of the solutions “with pre-treatment” in Figures 4-7 and 4-8, the changes in temperature were similar to when the explosion and fire occurred with the actual equipment. Therefore, it is assumed that the rise in temperature in the upper liquid phase where there was no cooling coil occurred due to heat decomposition of the HPO under these conditions.

It should be noted that there was a difference in the heating speed when no pre-treatment was conducted, as shown in Figure 4-7.

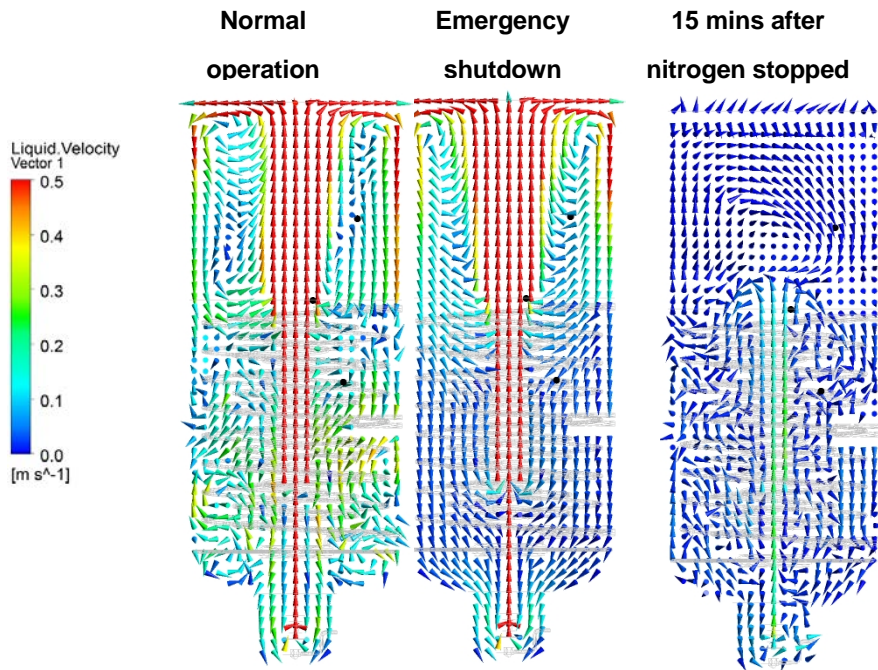
Figure 4-9 Changes in the liquid velocity vector

As a result of analyzing the flow conditions after the nitrogen supply for agitation was stopped, it was determined that as time passed, the liquid flow throughout the reactor dropped and 15 minutes after the nitrogen supply was

stopped, only a slight upward flow in the draft tube and some flow around the coil could be seen, and the liquid around the upper liquid phase where there was no cooling coil was almost completely still and no liquid was exchanged with the lower liquid phase (Refer to Figure 4-9).

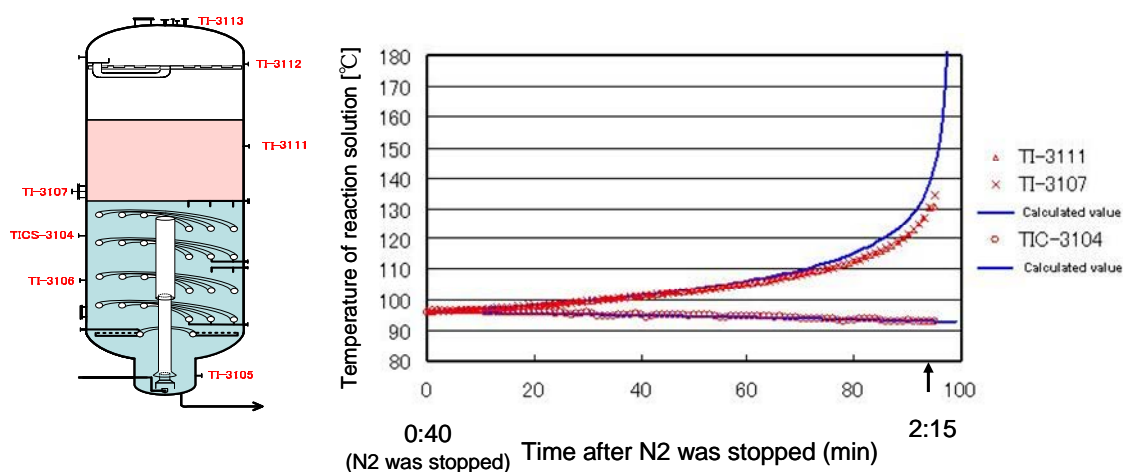
Figure 4-10 Changes in temperature in the oxidation reactor after the nitrogen supply is stopped and results of calculation

Additionally, verification was made of the changes in temperature in the upper and lower liquid phases after the nitrogen supply was stopped. The initial temperature of the liquid was set at 96°C and it was assumed from the flow conditions that there was no exchange of liquids between the upper and lower liquid phases. The changes in temperature at each point were calculated based on the heat balance of the HPO decomposition heat and the heat removal from the cooling coils. As a result, the calculated value of the temperature of the oxidation reactor showed similar trends as the actual temperatures recorded the day of the accident (Refer to Figure 4-10). Based on this, it is thought that the temperature in the lower liquid phase dropped gradually as it was cooled and the temperature rose in the upper liquid phase due to the decomposition reaction of the HPO.

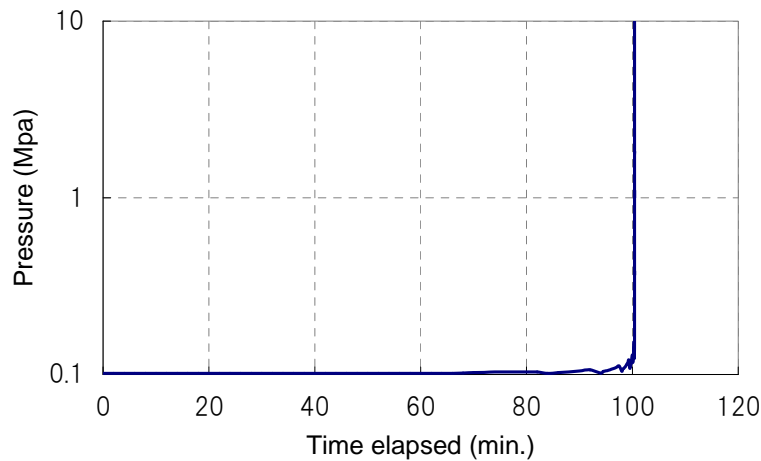
Figure 4-13 Estimated change in pressure over time

By solving the two equations as a system of equations, the changes in the temperature, speed of gas generation and pressure over time after the nitrogen supply for agitation was stopped could be estimated as shown in Figure 4-13 and the results showed that the pressure would eventually exceed 10 MPa.

Additionally, the internal pressure when the oxidation reactor burst was estimated to be 8 MPa or higher from the elasto-plastic analysis using FEM and the rupture stress of the manhole bolt, and combining that with the results of the calculations above, it is assumed that the rise in pressure from the gas generated caused the reactor to burst.
