Report on Accident at Production Facilities at Shimonoseki Mitsui Chemicals, Inc.

Mitsui Chemicals, Inc. ("MCI") and Shimonoseki Mitsui Chemicals, Inc. ("SMCI") once again extends sincerest apologies to all those who suffered injuries, the residents of the local community and all other parties concerned and affected by the November 4, 2009 accident at the filling area of the nitrogen trifluoride (NF<sub>3</sub>) production facility (Line F3/F4) at Shimonoseki Mitsui Chemicals, Inc.

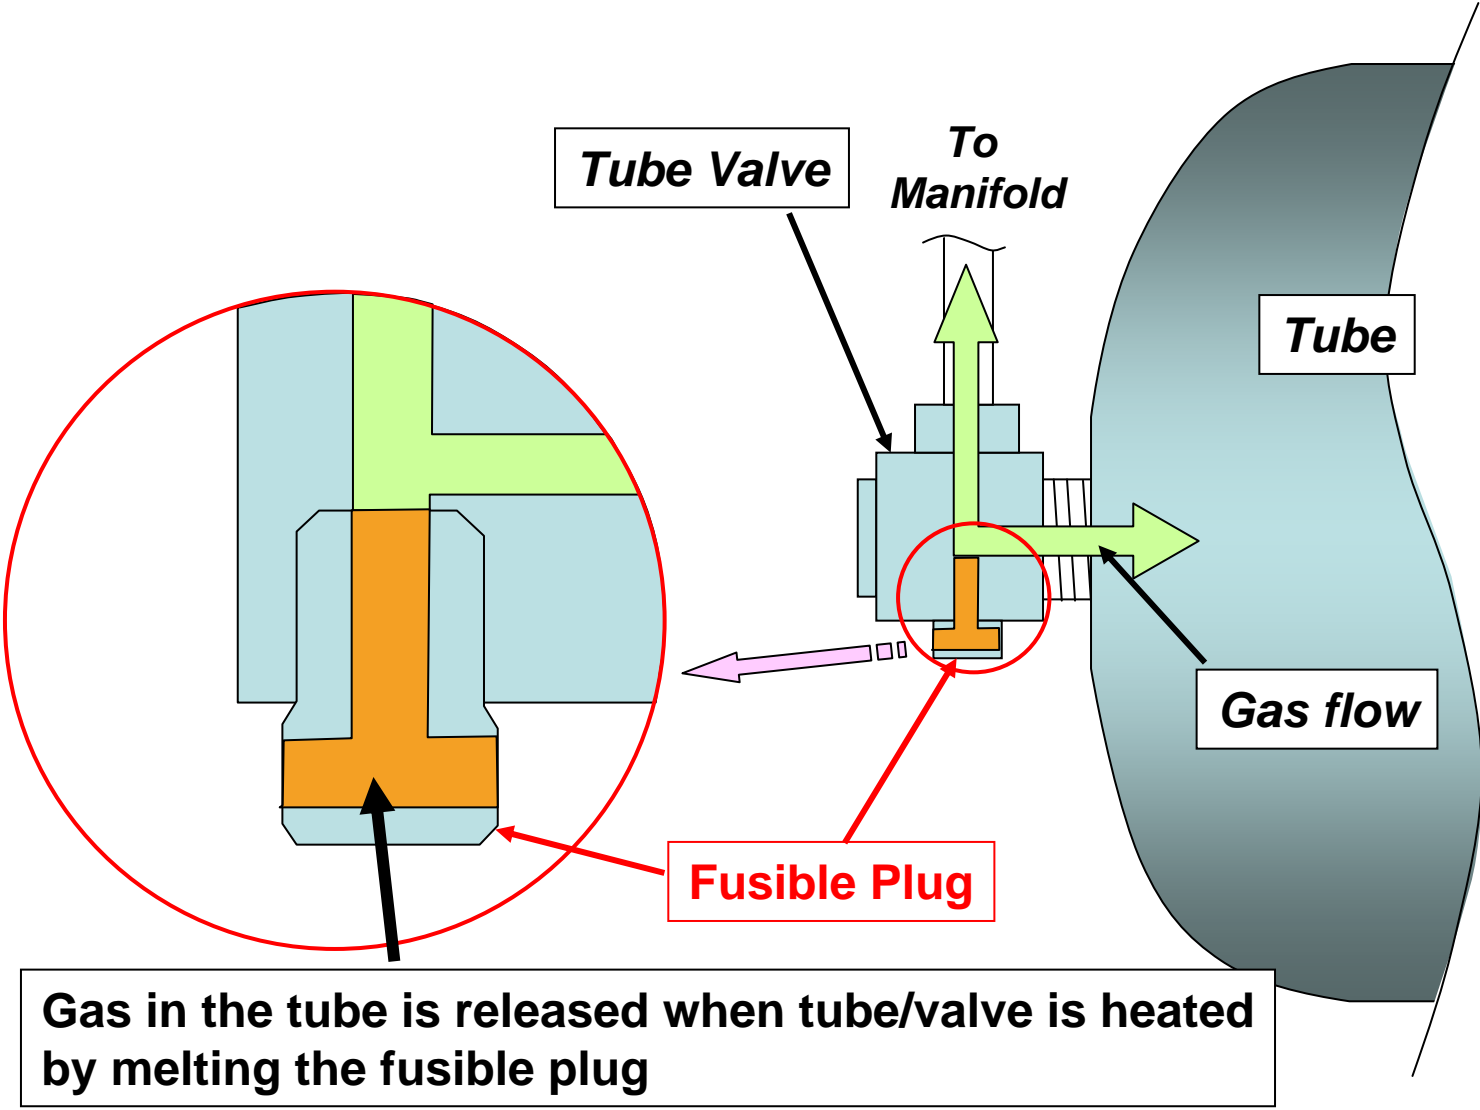
Ref. What is tube valve and fusible plug

# Mechanism of the fusible plug failure

- Stainless steel on the surface of flow route was reacted with NF3
- PCTFE around diaphragm seat was burned.
- PCTFE packing around fusible plug was burned.
