Accident Investigation Committee Report on
the Iwakuni-Ohtake Works Explosion and Fire

Mitsui Chemicals Iwakuni-Ohtake Works
Resorcinol Plant
Accident Investigation Committee Report

Resorcinol Plant Accident Investigation Committee
Mitsui Chemicals Iwakuni-Ohtake Works

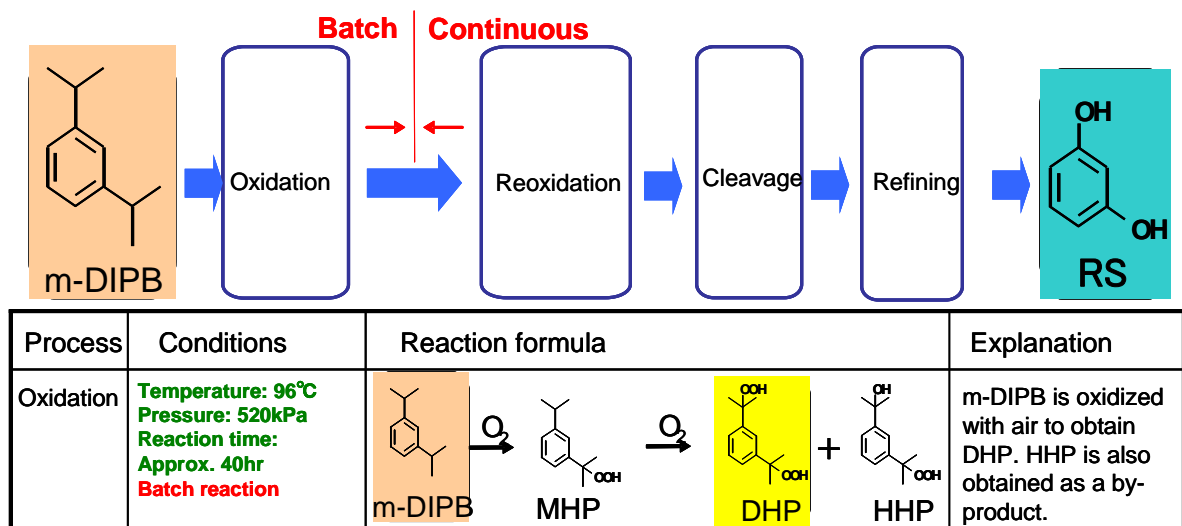
Figure 3-1 Resorcinol plant block flow and reaction formula

At the resorcinol plant, m-Diisopropylbenzene (m-DIPB) was oxidized with air to create the intermediate, Dihydroxy peroxide (DHP), and the acid catalyst cleavage reaction of the DHP was used to produce resorcinol.

The aimed product of the oxidation process was DHP but the hydroperoxide (HPO, a collective name for the peroxides generated) that was actually generated was a mixture that contains by-products such as hydroxy hydroperoxide (HHP). HHP was collected as DHP at the next process, the reoxidation process. The oxidation process is a batch reaction and the processes, from reoxidation and onwards, are continuous reactions, and an intermediate tank was used to connect the two.

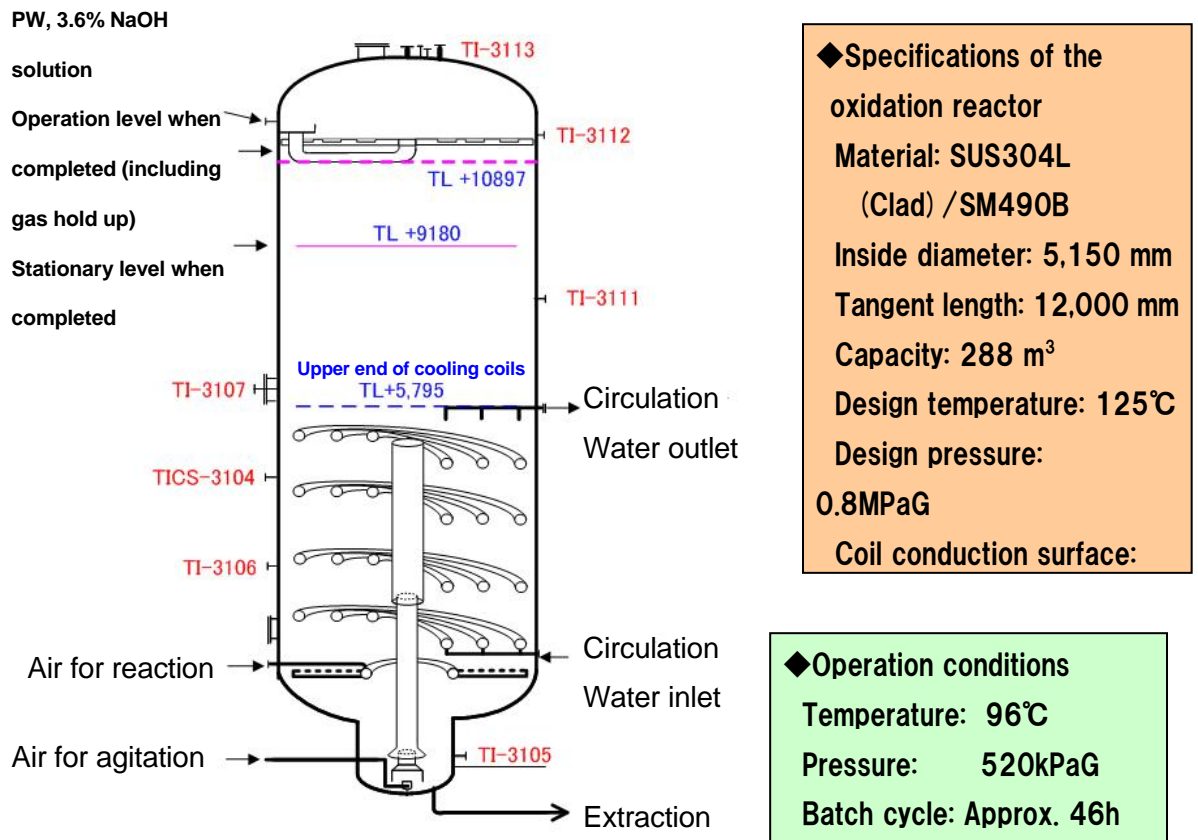
Figure 3-2 Specifications of the oxidation reactor

Figure 3-2 shows the specifications of the oxidation reactor.

The reaction temperature is controlled using the temperature of the circulating water at the inlet to the cooling coil to adjust the thermometer TICS-3104 to the target temperature.

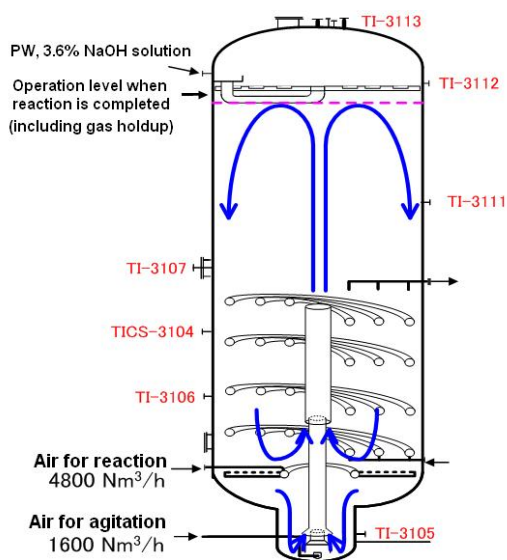
Figure 3-3 Image of the agitation in the oxidation reactor

The air supplied to the reactor is used for both reaction and agitation. A steady volume of air is supplied for both reaction and agitation during reaction. The reaction air is supplied as tiny bubbles by passing it through the sparger. The air for agitation is supplied from the bottom part of the draft tube installed at the center of the reactor, and the entire liquid phase is agitated through air lift agitation. Overall, the center of the reactor has an upward flow and the area near the reactor walls has a downward flow. Figure 3-3 shows the agitation condition of the oxidation reactor.

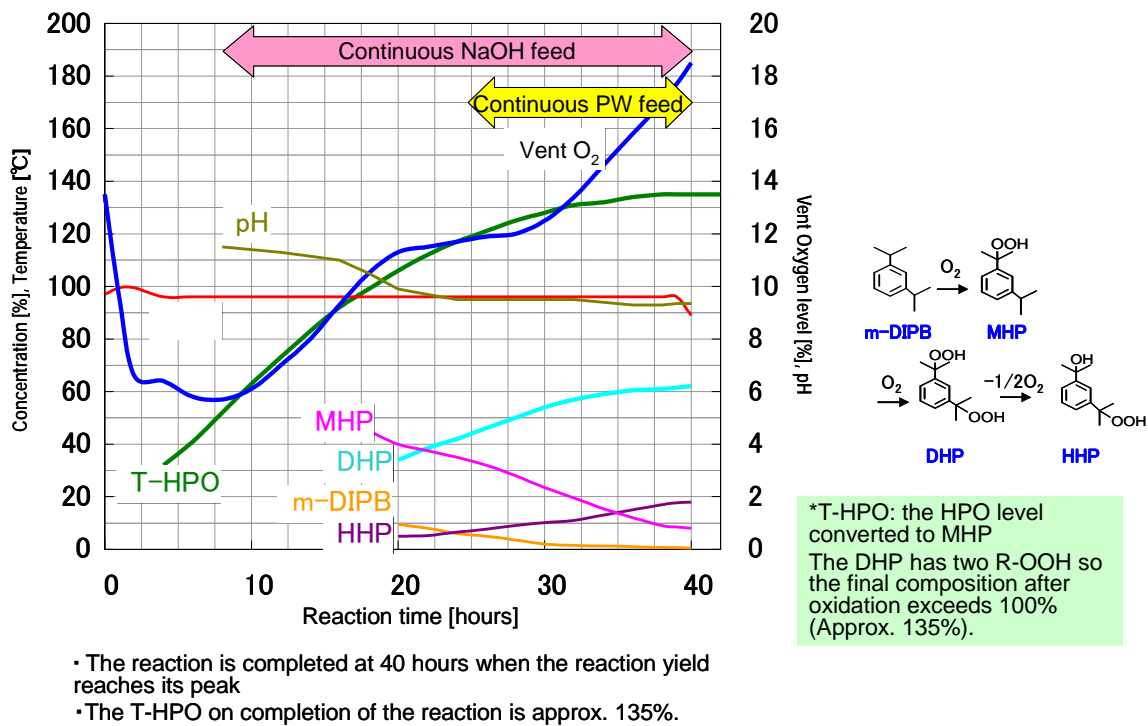
Figure 3-4 Temporal changes in oxidation reaction

As this reaction progresses, organic acids and methanol are generated. In order to adjust the pH and viscosity, 3.6% NaOH water solution and pure water is supplied part way through the reaction.

T-HPO (total hydroperoxide concentration) is used as a measure of the progression of the reaction. This is a hydroperoxide concentration that is converted to MHP, and since DHP has two R-OOH radicals in the same molecule, when converted to MHP, the figure is doubled. When the reaction is completed, the T-HPO concentration is approximately 135%.

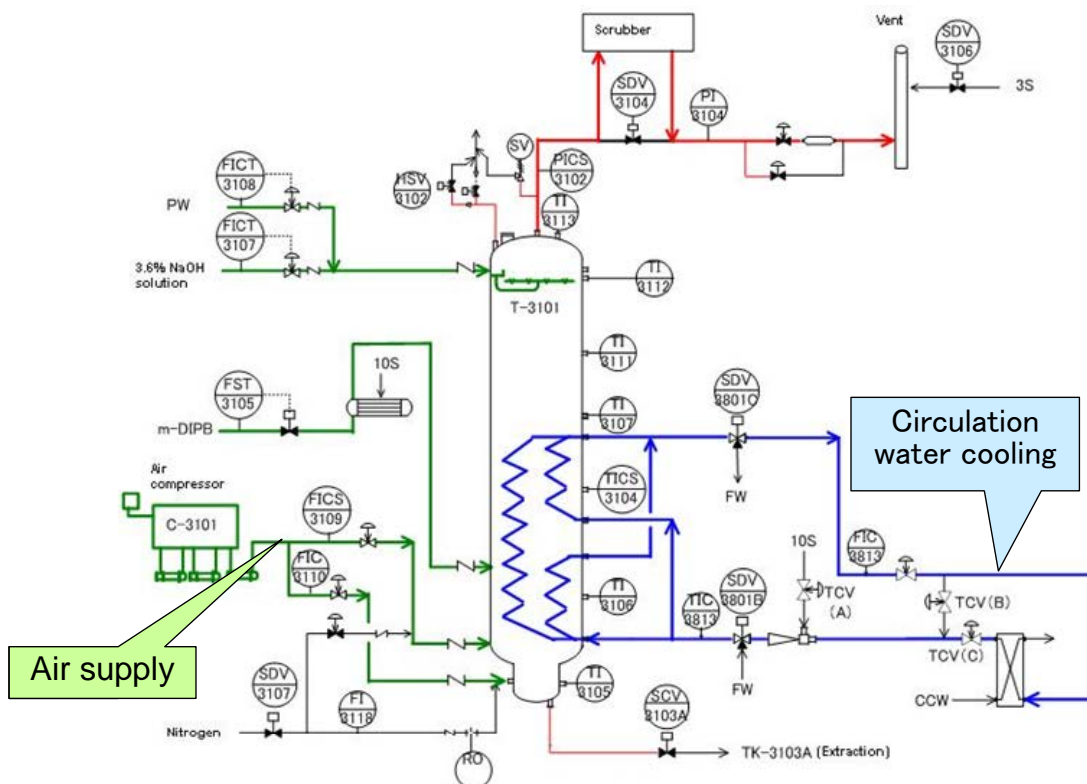
Figure 4-1 Flow during normal operation (Batch reaction started April 21 at 23:32.)

- April 21 23:20
- The resorcinol oxidation reactor was operating normally. They were 36 hours into the 40 hour batch reaction.
 - The utilities plant had stopped and as a result, the steam supply was stopped and an emergency order was issued to all plants (for plants using 3 kilo steam to stop operations).
- 23:32
- The emergency shutdown (ESD) switch was activated at the resorcinol plant. The interlock was activated properly and the air supply was stopped. The oxidation reaction was stopped and nitrogen was supplied to the reactor to prevent the contents from reaching the explosion range. Additionally, cooling water for the oxidation reactor was switched from circulating water to emergency cooling water (FW).

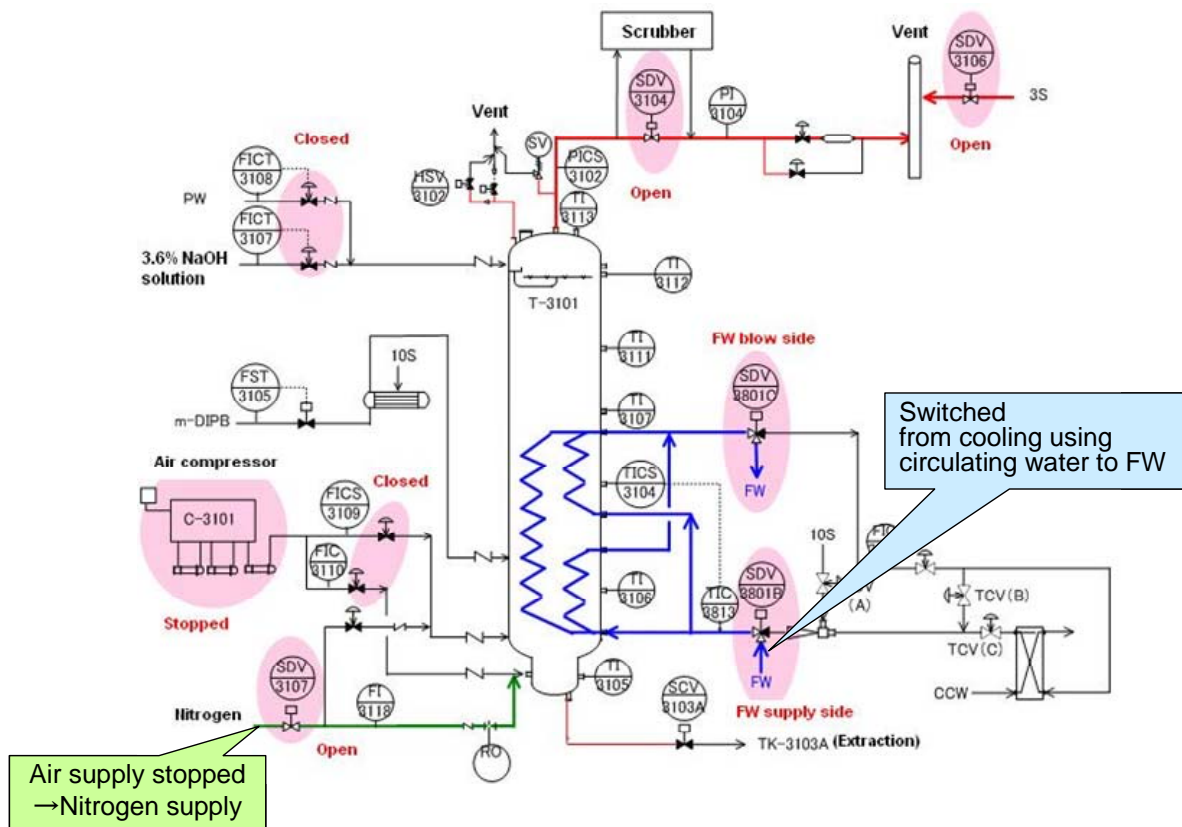
Figure 4-2 Flow during emergency shutdown (ESD) (When the interlock is activated)
 (23:32 on April 21 to 0:40 on April 22)

- ~23:52
 - After the interlock was activated, since the temperature in the lower part of the liquid phase (TICS-3104, with cooling coil) did not drop, the operator checked onsite and found that the onsite pressure for FW was low at 0.3 to 0.4 MPaG. The FW pressure was low and the FW flow was insufficient so the operator thought the reactor temperature would not drop. He made a request to the utilities plant to raise the pressure of the FW and it was raised.

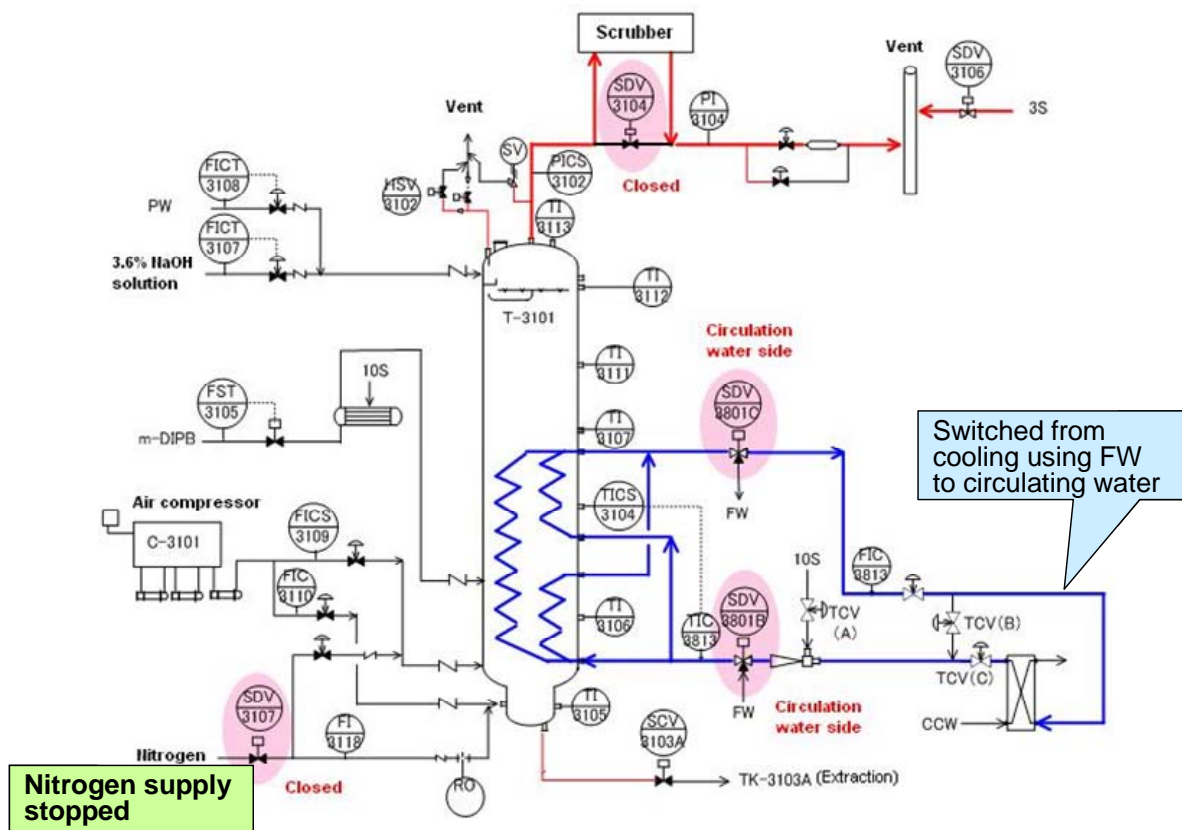
Figure 4-3 Flow for releasing interlock (0:40 to 2:15 on April 22)

- 0:44~
- After the cooling water was switched from FW to circulating water, the temperature in the lower liquid phase (TICS-3104, with cooling coil) continued to drop. At the same time, because the nitrogen supply was stopped and agitation was stopped, the temperature in the upper liquid phase (TI-3107 and TI-3111, no cooling coil) which was the same as the lower liquid phase after the emergency shutdown, began to rise.

- 1:45
- Even though the PW was added, the temperature did not drop. This is when the operator realized that the nitrogen supply for agitation was stopped. He began to confirm the operation condition. He thought that since the oxygen level was 0% that the nitrogen exchange had been successful, and the pressure was 0.52 MPaG which was normal in a controlled situation.

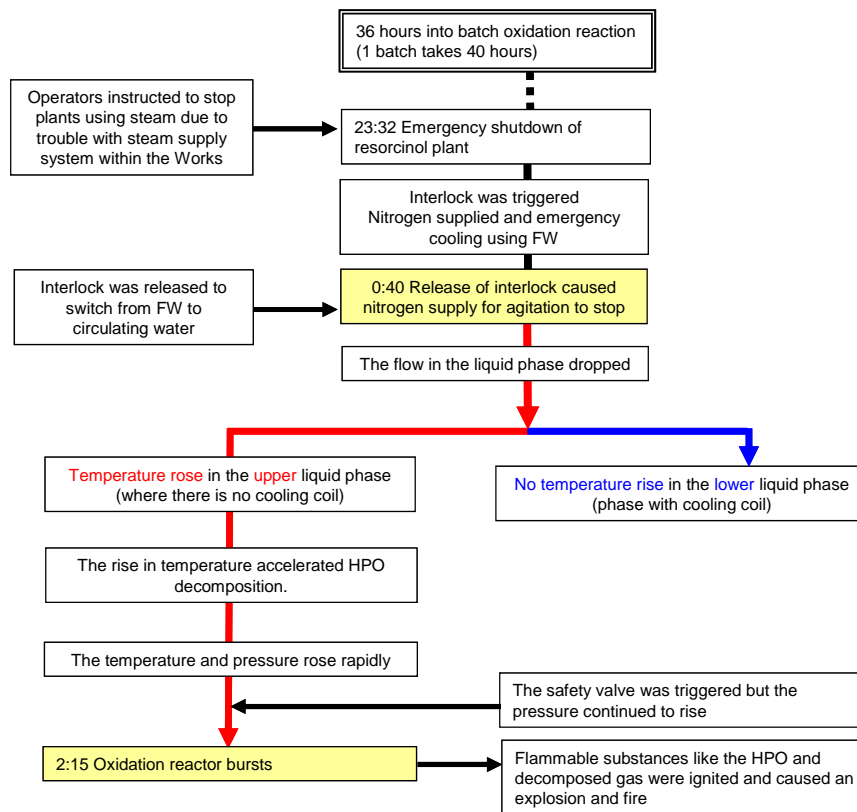
Figure 4-5 Flow of events leading up to the explosion and fire

Figure 4-5 shows the main points of the events that led to the accident in a time series.

Based on the Flow of events leading to the explosion and fire (Fig. 4-5) shown in the previous section, the events leading up to the rupturing of the oxidation reactor can be summarized as follows.

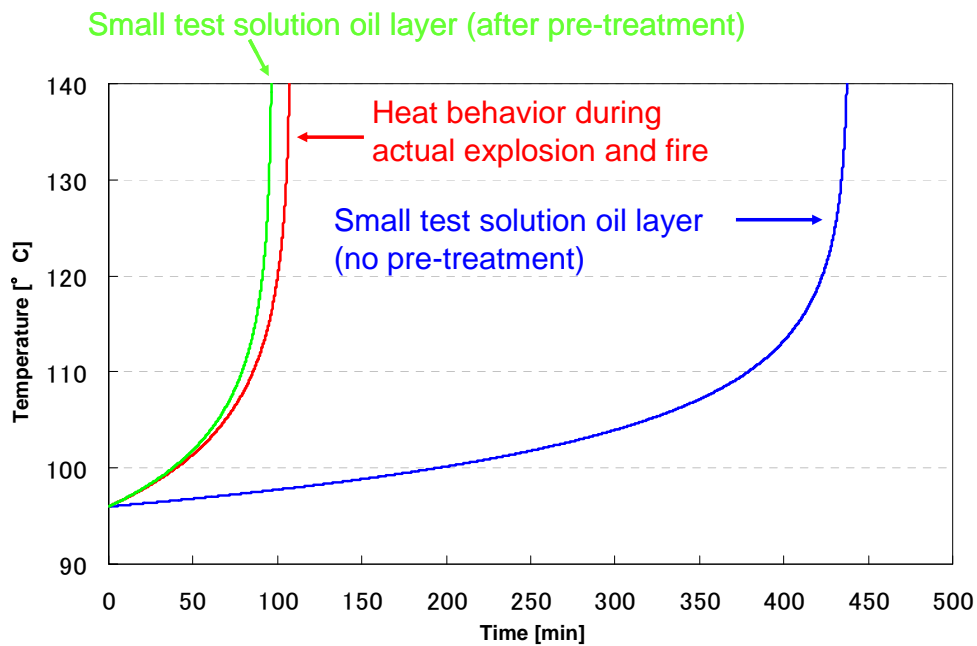
Figure 4-8 Changes in temperature (estimated from the Arrhenius formula)

Next, an Arrhenius plot was used to organize the ARC measurement data and as you can see in behavior of the solutions “with pre-treatment” in Figures 4-7 and 4-8, the changes in temperature were similar to when the explosion and fire occurred with the actual equipment. Therefore, it is assumed that the rise in temperature in the upper liquid phase where there was no cooling coil occurred due to heat decomposition of the HPO under these conditions.

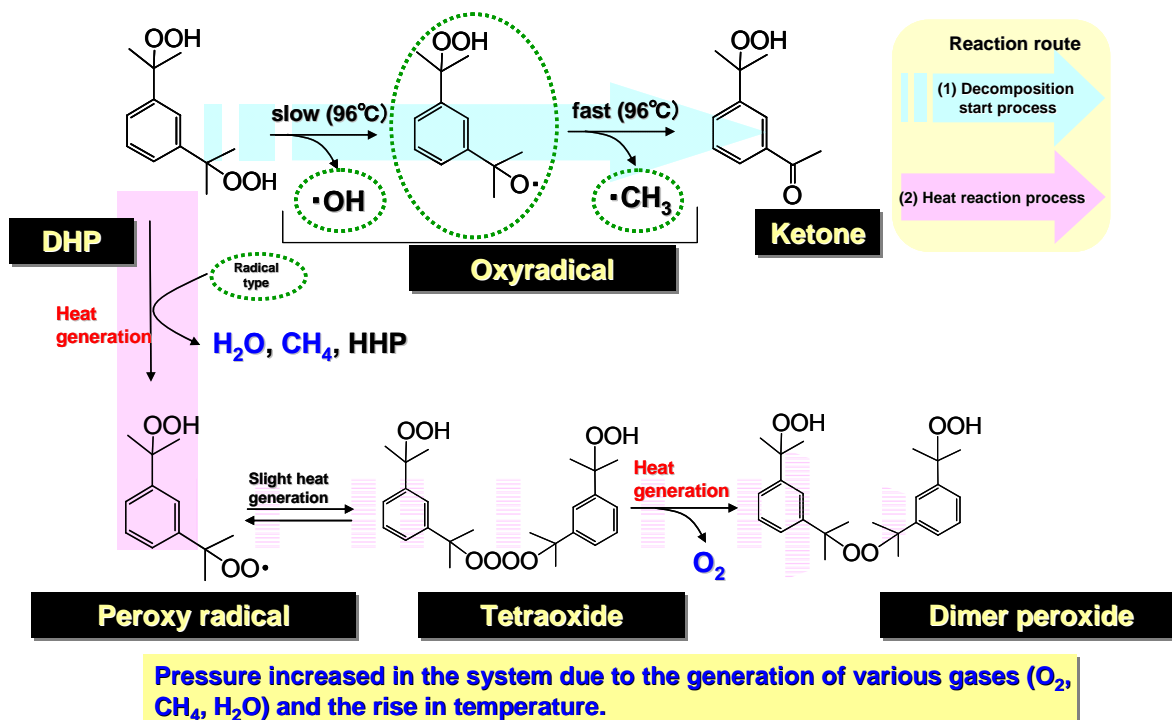
Figure 4-11 DHP decomposition reaction mechanism that can be estimated from computational chemistry

The decomposition reaction mechanism of DHP was estimated using a computational chemistry method. As shown in Figure 4-11, first there is the process when the DHP decomposition begins with the generation of radicals. Next, there is heating reaction process where the radicals and the DHP react to generate peroxy radicals and peroxide dimer. During this heating reaction process, gas is generated from the water, methane and oxygen. Through confirmation of the small test solution in a heat decomposition test, the volume of gas generated tended to increase as the temperature rose, and the composition of the gas was 40 to 60% methane. (Refer to Figure 4-12)

From this, it can be assumed that with the rise in temperature, the radical cleavage and the heating reaction of DHP, a main ingredient of HPO, were gradually accelerated and the amount of gas generated increased as the temperature rose, resulting in the rise in pressure.

*The three types of radicals are highly reactive, so they mostly disappear after reacting with DHP.

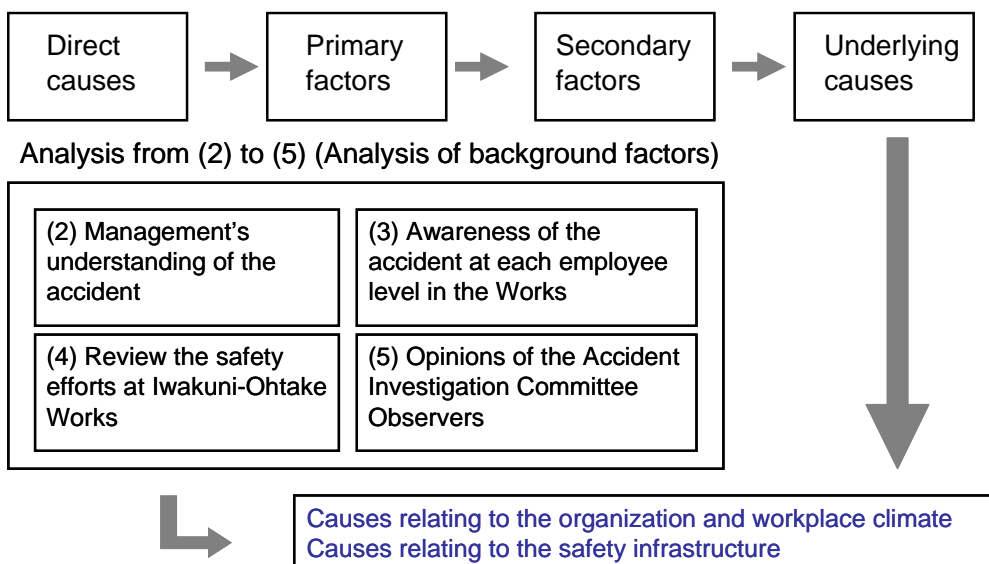
Figure 6-1 Flow chart of Analysis of underlying causes

An overview of the analysis as a whole is shown in Figure 6-1. Next, an overview of the analysis results of each method is shown in Table 6-1.

Analysis method	Overview of Analysis Results
(1) Expansion of the direct cause	The underlying causes expanded from the secondary factors of the direct cause were “insufficient risk assessment”, “insufficient passing down of skills”, and “disregarding regulations and rules”.
